**Report No: CG-D-06-11**

# CSSC Fish Barrier Simulated Rescuer Touch Point Results, Operating Guidance, and Recommendations for Rescuer Safety

## Interim Report

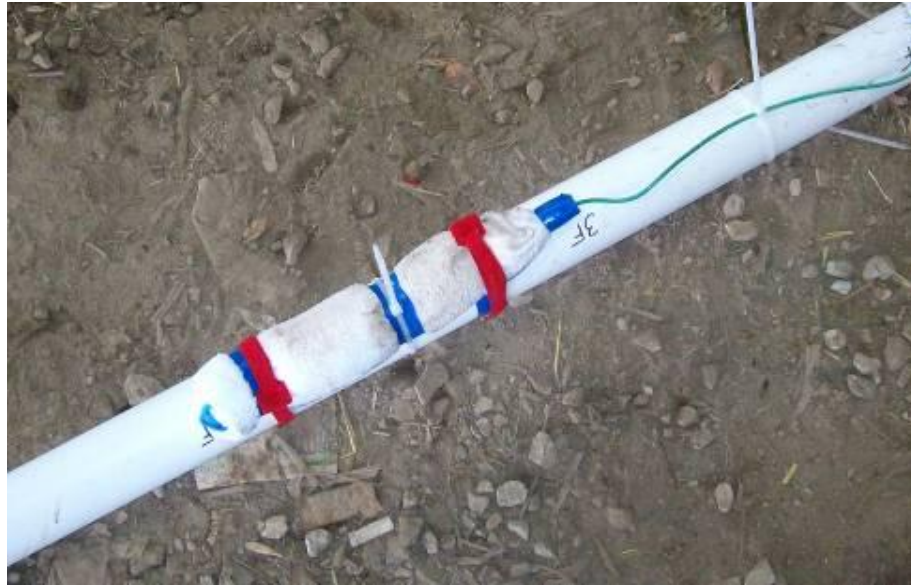
Figure 2. Input electrode.

During assembly, we soldered a short length of 12 American Wire Gauge (AWG) stranded copper wire to the copper rod within each electrode. For each electrode pair, we joined electrode wires to separate conductors of a shielded, commercially available, underwater-rated electrical cable (three-conductor, shielded, shipboard cable (TSS)-2, 18 AWG stranded copper). Electrode pairs shared a single signal cable to minimize interference from external sources during testing. Figure 2 shows an input electrode.

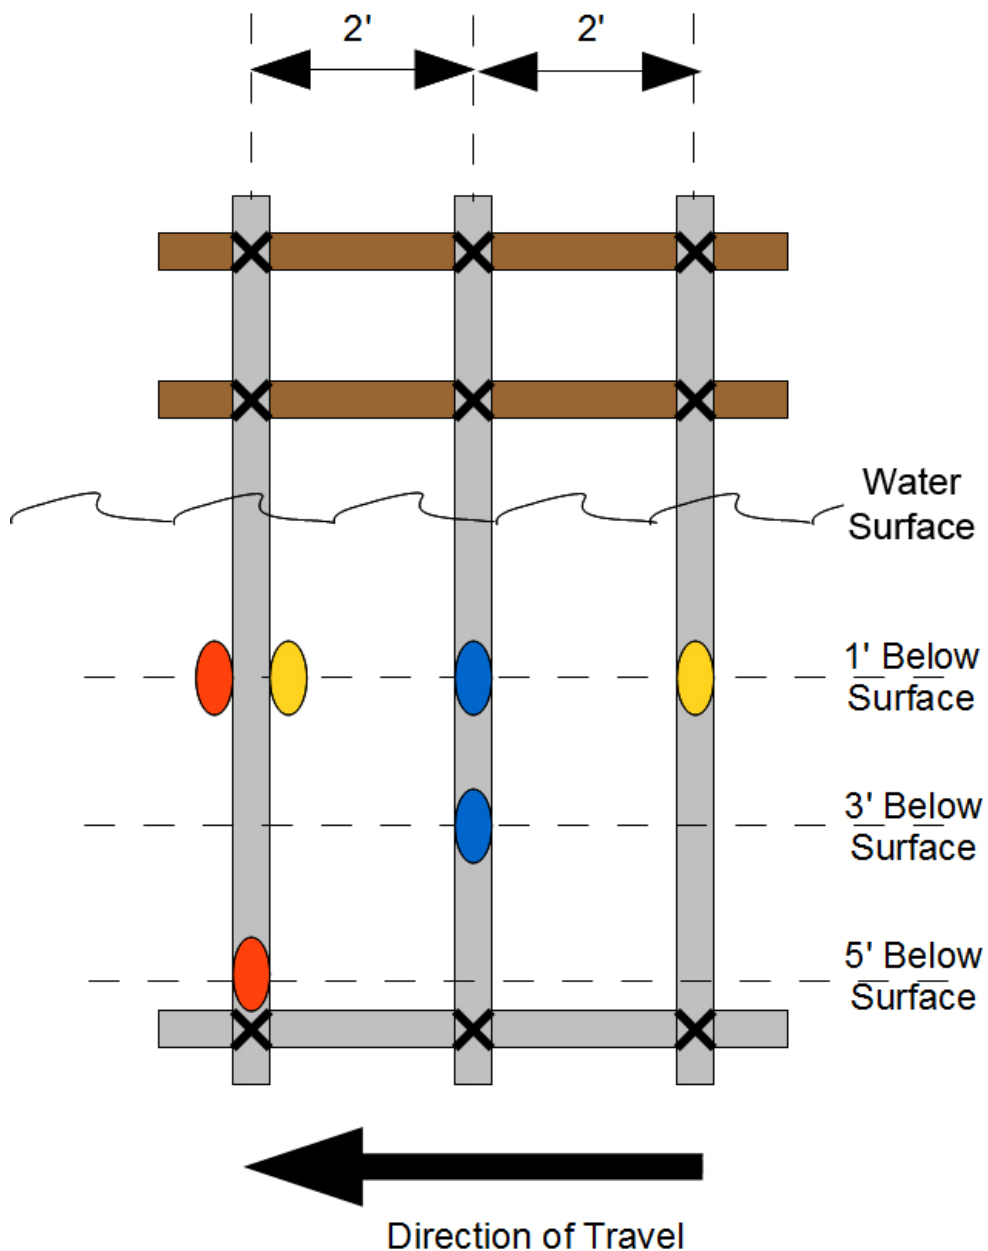
Figure 3. Configuration of electrode sensor array with color-coded electrode pairs.

We mounted six electrodes to the frame to create three pairs of electrodes as seen in Figure 3 and Figure 4. We attached the cloth-wrapped, salinated clay electrodes to the vertical pipes of the frame using waterproof electrical tape along with nylon and Velcro® tie-wraps to provide extra security, and wrapped with colored electrical tape (yellow, red, and blue) to provide ease of identification for each pair of electrodes: yellow 4-foot horizontal separation, blue 2-foot vertical separation, and red 4-foot vertical separation. These dimensions were selected to simulate the relative separation between hands, feet, and torso of an unconscious PIW wearing a Type I personal floatation device (PFD). We routed and secured the electrode signal leads along the PVC pipes and connected them above the water line to the data acquisition system input cable.

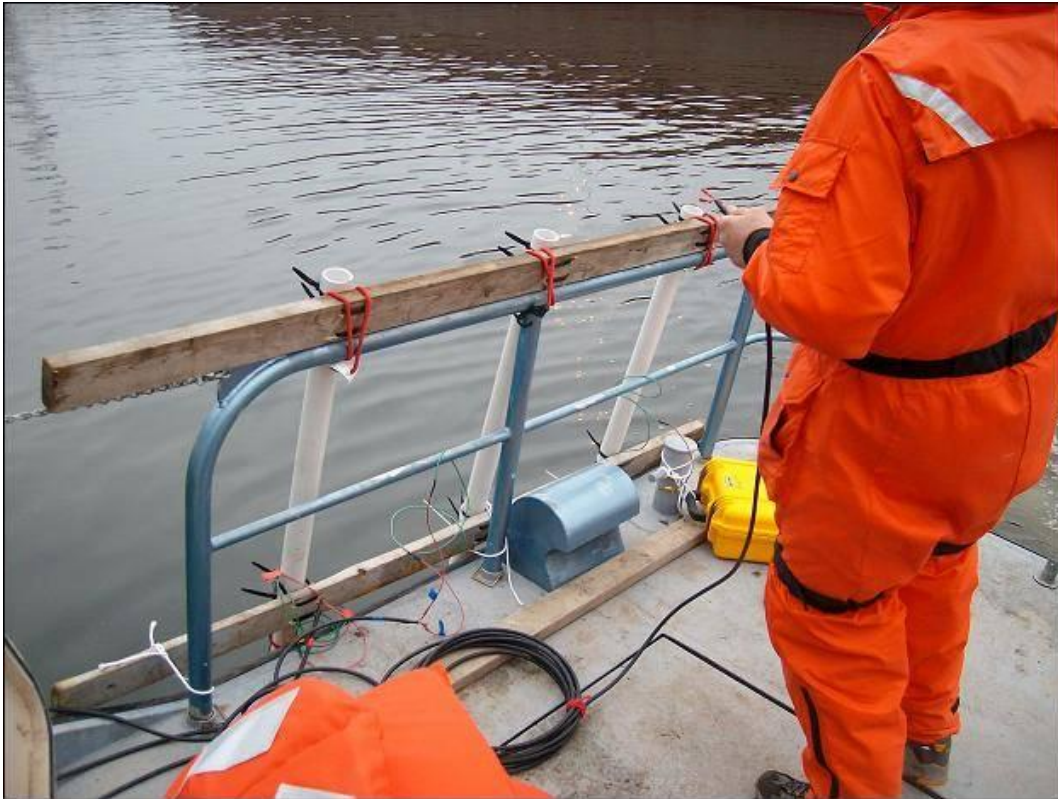
Figure 5. Installation of probe frame on test vessel.

We carried the array on the deck of the test vessel and only deployed it into the water upon arriving at the survey area. We mounted the deployed sensor array to the test vessel railing using bungee cords (Figure 5). During the survey, the probe frame proved to be quite robust and stable at the typical range of survey speeds of up to 3 mph. Upon completion of each test day, we retracted the electrode array from the water and stowed it on deck for transit back to the L&R facility at Lemont.

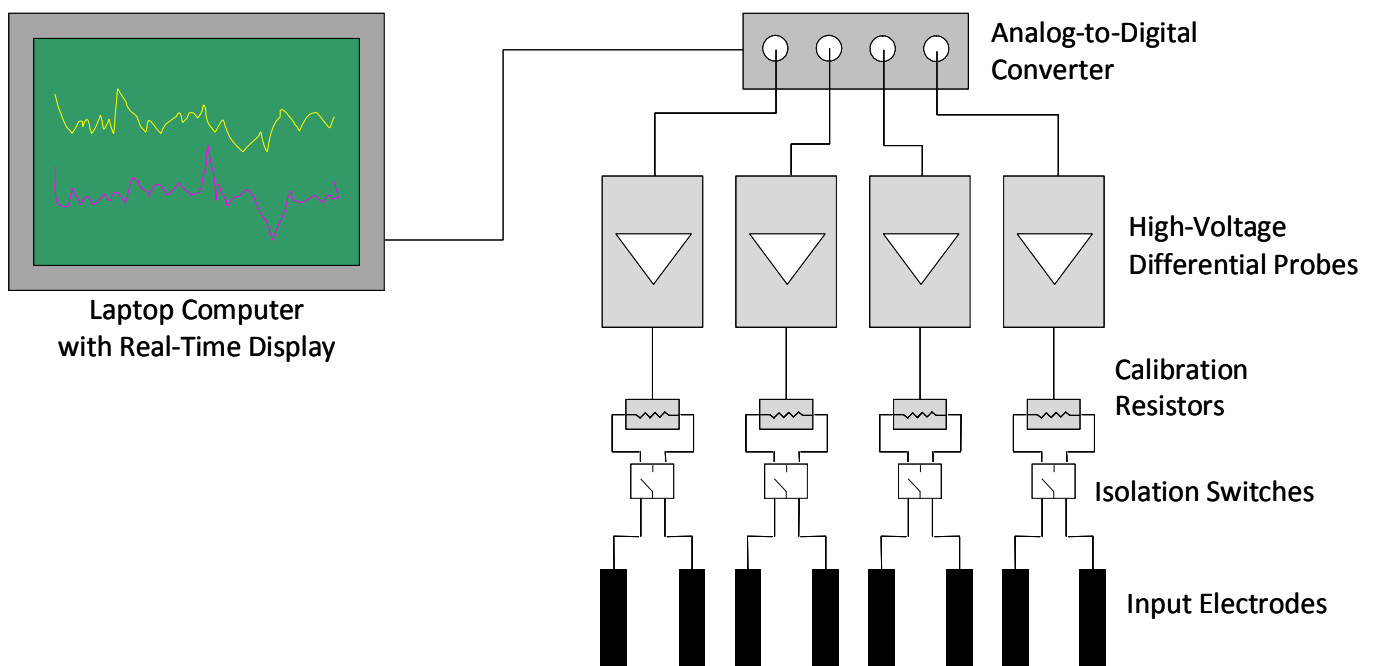
Figure 6. Electric field recording system block diagram.

The data acquisition collection system included a Dell D520 laptop computer, a 4-channel analog-to-digital (A/D) converter, high-voltage differential probes, measurement resistors, and input electrodes. Figure 6 depicts a top-level block diagram of the data acquisition system. We wired the input electrodes installed on the array frame to the data acquisition system inputs via submersible electrical cables. We used the electronics, which were housed in a weather-proof case, to sample, digitize, and store collected data onto the laptop hard drive for real-time monitoring, playback, and analysis.

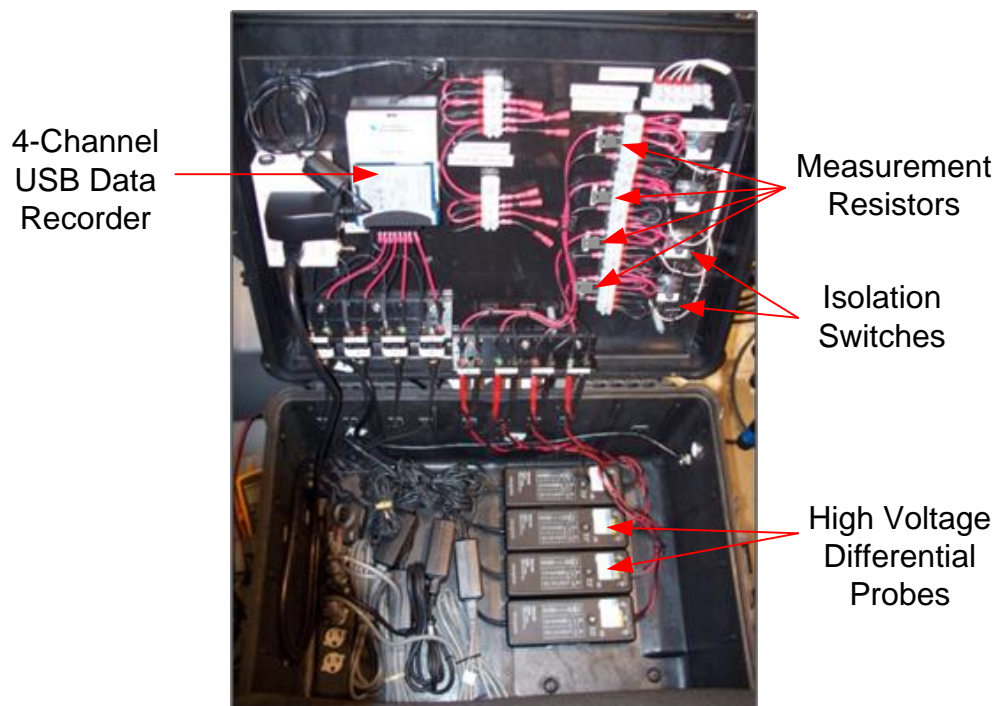
Figure 7. ShockWave test box physical set-up.

We wired three-pole, double throw switches to the input side of the test box to enable the user to completely disconnect and isolate the test box from electrodes in the water if required for testing or system reconfiguration. We used these switches between test condition set-ups, and they were necessary during troubleshooting of the system while deployed. We used Tektronix P5200 High-Voltage Differential Probes for each channel of measurement for voltage stepdown and circuit protection and personnel safety. Each P5200 contains optical isolation circuitry that prevents excessive voltages on the signal side of the unit that could damage the low voltage circuits on the recorder. This protection was necessary due to the high voltages produced by the barriers. The P5200s were powered by a 9 volts direct current (VDC) supply and were configured for a 1:50 stepdown rate.

We measured voltage levels across commercial high-power resistors of a nominal 100 ohm resistance. The high power rating (100 watts) allowed safe use and substantial power dissipation when exposed to high voltages from the barrier. We wired the measurement resistors in series with the input electrodes. We prepared a set of current-sense devices powered by a 12 VDC supply in the event that the 1:50 high-voltage probes did not allow sufficient dynamic range to capture sensed electrical current. We did not use these current sensors for data collection during the test period. Figure 7 shows the measurement test box; Appendix A provides an electrical schematic.

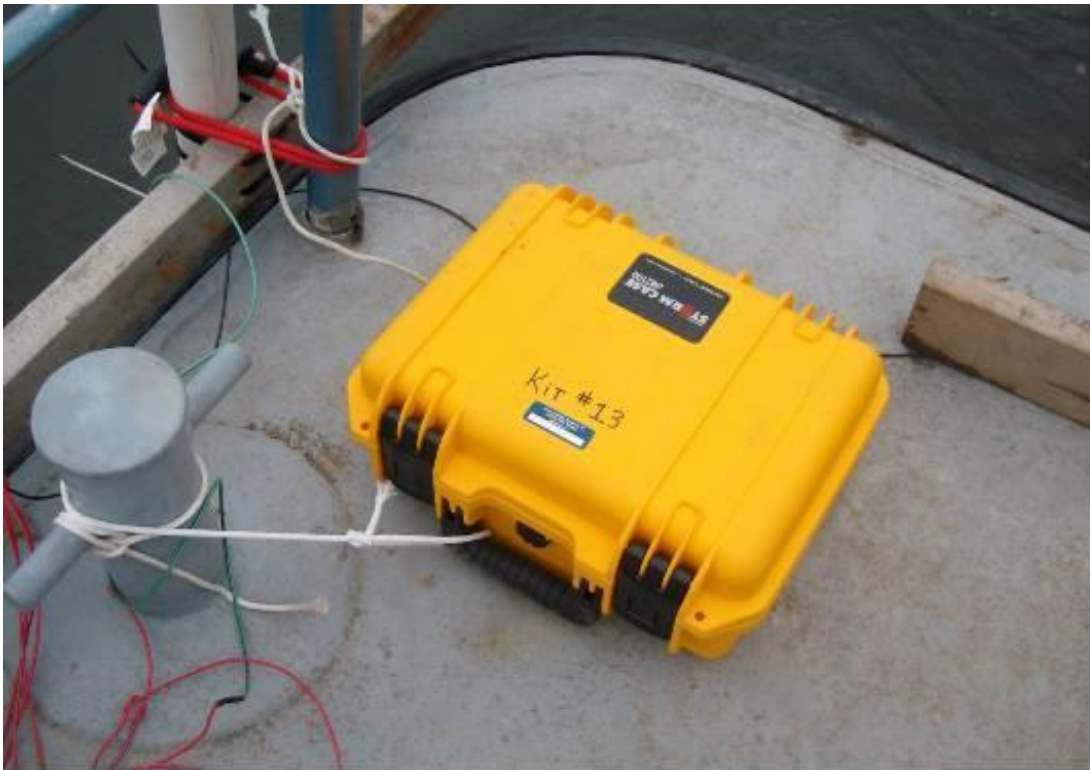
Figure 8. GPS receiver and logger on aft deck of test vessel.

Portable GPS receivers with built-in data logging capabilities provided positional information during periods of data collection. We used two units to periodically record test vessel position as a function of time, one unit as the primary, and the other as a backup. We staged GPS units on the rear deck of the test vessel immediately adjacent to the sensor probe array (see Figure 8).

During the survey, two onboard GPSs continually and simultaneously recorded the test vessel position at a rate of approximately 10 to 12 times a minute. Data recorded by the GPS included: latitude (DD.DDDDDD format), longitude (DD.DDDDDD format), date (ddmmyy), time (hhmmss) relative to Greenwich Mean Time (GMT), vessel speed (mph) and vessel track (degrees magnetic), and other data. Table 2 shows the basic recording format with a segment of run data from 18 November testing. We computed positional graphs of test vessel transects each run day for each test condition and time-synchronized them to the recorded electric field data.

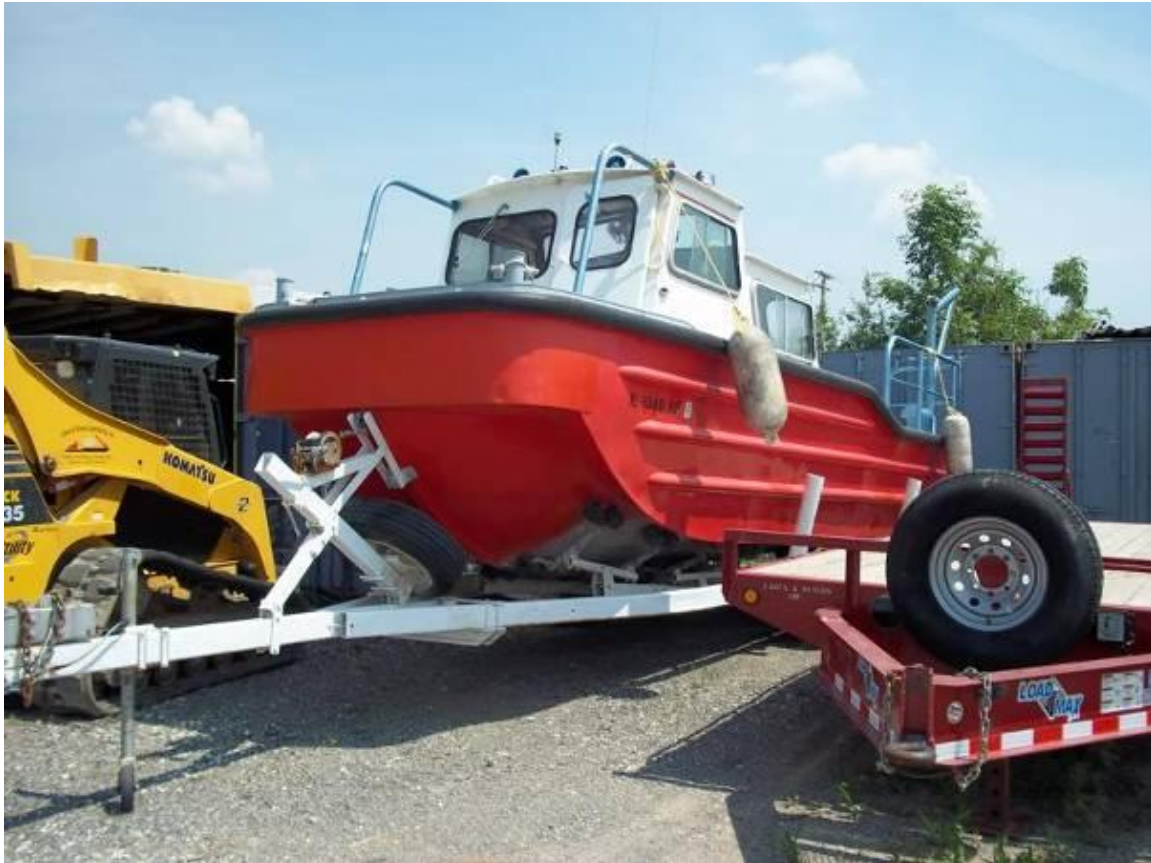
Figure 9. L&R test vessel.

The test vessel (Figure 9) was approximately 26 feet in length, and equipped with a cabin and rear work deck with safety railings. As previously described, we mounted the test electrode array outboard on the aft starboard rail, and routed waterproof electrical cables with electrical sensor signals from the electrodes to the recording sensing and recording equipment located in the vessel cabin. The test vessel's aluminum hull provided reliable electrical continuity to the water in the canal. We did not determine the specific electrical path from the topside grounding location to the water via the hull.

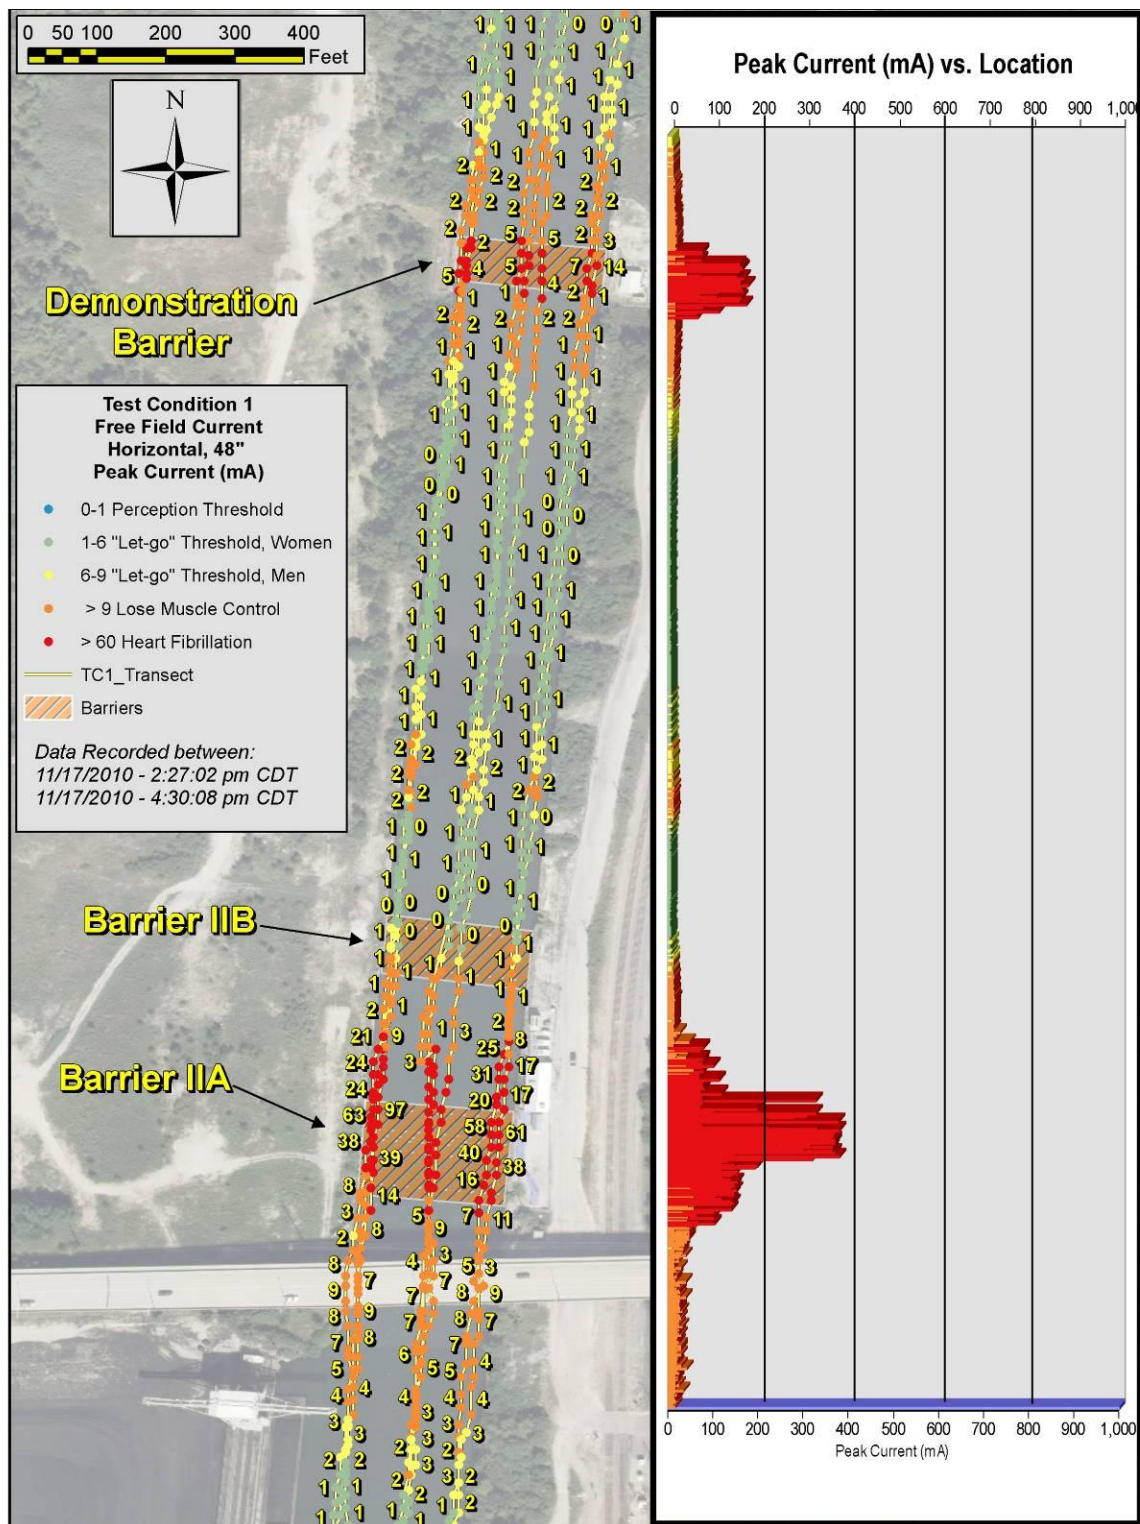
We observed significant electrical currents in this test condition. Electrical current flow varied with electrode separation because a wider probe separation provided a larger voltage gradient between electrodes. The maximum current measured occurred horizontally along the direction parallel to the canal axis, with peak levels of 380 milliamperes (mA) (see Table 5). Figure 10 shows the peak free-field electrical current between horizontal electrodes, 48 inches apart, oriented parallel to vessel track. Maximum vertical levels measured were 184 mA with a 48-inch vertical electrode spacing, which simulates the position of a person in the same orientation, and with wetted feet and neckline, submerged below the water surface. We observed maximum levels adjacent to Barrier IIA, which was the expected result due to the higher voltage levels produced by this barrier in comparison with the levels produced by Barrier I (the demonstration barrier).

Figure 10. Peak free field electrical current (mA) between horizontal electrodes, 48 inches apart, oriented parallel to vessel track.

The objective of this test was to measure the electrical current flowing through the chest area of a PIW exposed to electric fields immersed in the CSSC. This condition simulated a PIW, wearing a Type I PFD, with outstretched arms, and hand-to-hand separation of 48 inches, hands in the water. Data from this condition verified voltages between electrodes from earlier USACE testing, and provided confidence that the instrumentation was working correctly. Measured levels parallel with the canal varied substantially as the test vessel transited across each barrier. Measured data did not vary significantly across the canal (center of the canal to the canal wall).

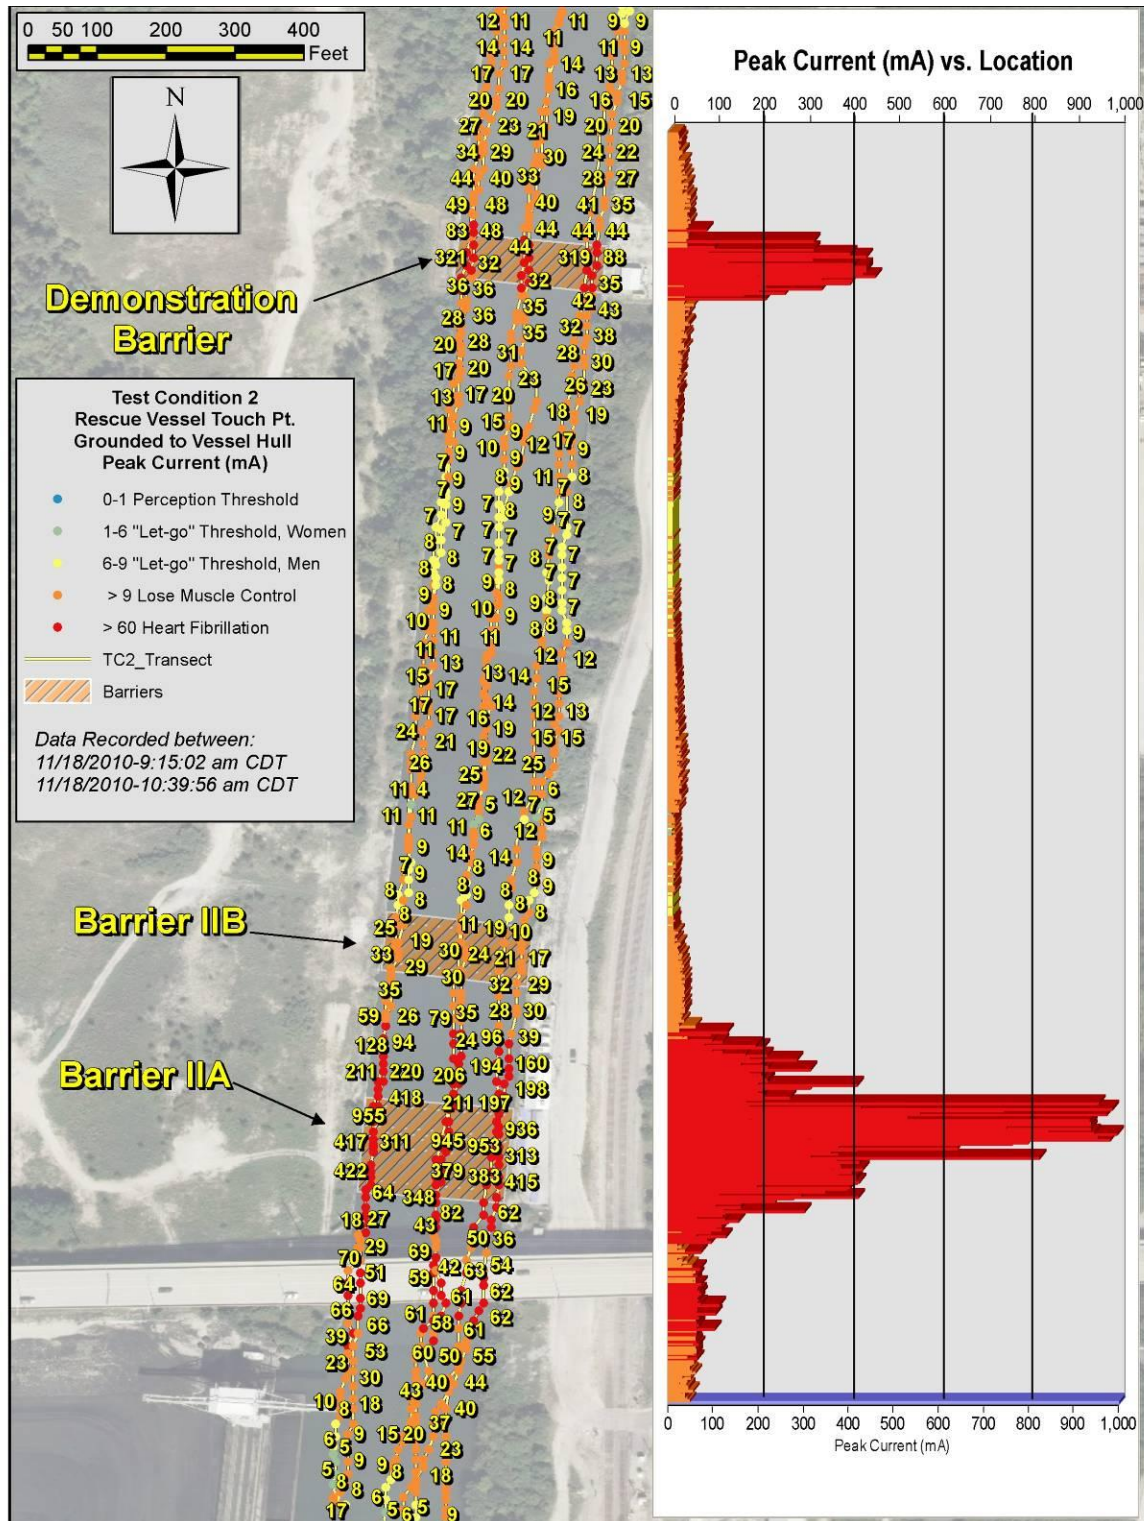
The objective of this test was to measure the electrical current flowing through the touch point of a rescuer on an aluminum boat, in contact with a floating PIW, with a current path through the rescuer's body, returning to the canal water through the aluminum hull of the test vessel. As in Test Condition 1, we observed significant electrical currents in this test condition. The maximum current measured in this condition was 973 mA in the vicinity of Barrier IIA (see Table 6), or nearly 1 ampere (amp) of current by grasping a floating PIW while the simulated rescuer is grounded to a metallic hull. Figure 11 shows the peak current flowing from a PIW in direct contact with the metallic hull of a rescue vessel. This test condition demonstrated that significantly higher electrical currents can be generated if a rescuer touches a metallic object electrically connected to the canal and then makes contact with a well grounded PIW. Furthermore, this test showed that the PIW should not be directly touching the hand of a rescuer on an aluminum boat. For this test, we executed a several transects through the center of the barrier zone and along both sides.

Figure 11. Peak rescue vessel touch point electrical current (mA) between simulated PIW and simulated rescuer on an aluminum boat.

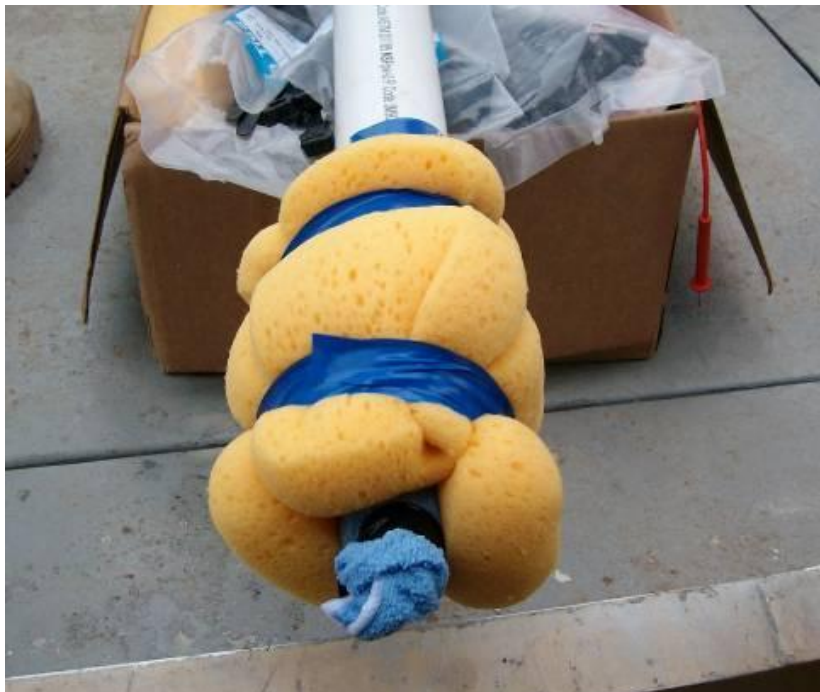
Because of the difficulty in holding position, we had to limit data cuts to 30 to 60 seconds in each location. We surveyed a total of 11 locations for touch point current, all of which were in the “hot zone” of Barrier IIA. At each location, the test engineer held the sponge electrode submerged near the wall to get an in-water baseline reading and to fully saturate the electrode, then he raised it from the water and held it against the canal wall approximately 18” above the waterline, finally releasing it and holding the electrode aloft (in the air). Thus, for each location, we established three data points: (1) electrical current flow with electrode in the water, (2) electrical current flow with electrode placed on the canal wall, 18” above the waterline, and (3) electrical current flow with electrode in-air; e.g., no contact with PIW or the water. Table 7 summarizes typical results, where the highest canal wall current flow readings were obtained. At this location, maximum current flow with the simulated rescuer on the wall with contact with a PIW was 41 mA. The nominal quiescent current with the probe in the air was approximately 0.14 mA (RMS). Figure 13 shows the test engineer equipped with the sponge electrode and pole apparatus.

Figure 12. Input electrode wrapped with open cell sponge.

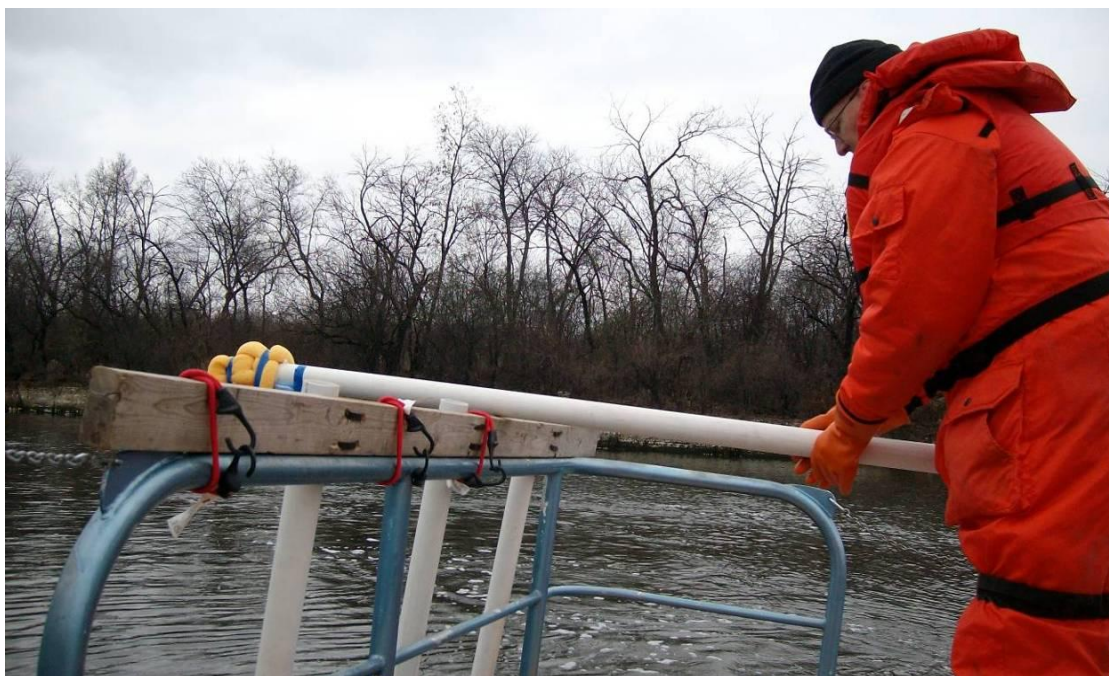
The objective of this test was to measure the maximum current flow from a floating PIW to a grounded rescuer on the canal wall, with a current path from the PIW to the rescuer, then returning to the barrier via a conductive path through the ground. We implemented this test condition with open cell sponges with intimate electrical contact with an input electrode wired to an in-water electrode to simulate a rescuer in contact with the canal wall, grasping a simulated PIW. A non-conductive PVC pole held the simulated rescuer electrode (see Figure 12) such that the test engineer could hold the electrode against the canal wall during recording while the test vessel operator maneuvered the test vessel near the wall.

Figure 13. Preparing for canal wall touch point current with pole and sponge electrode.

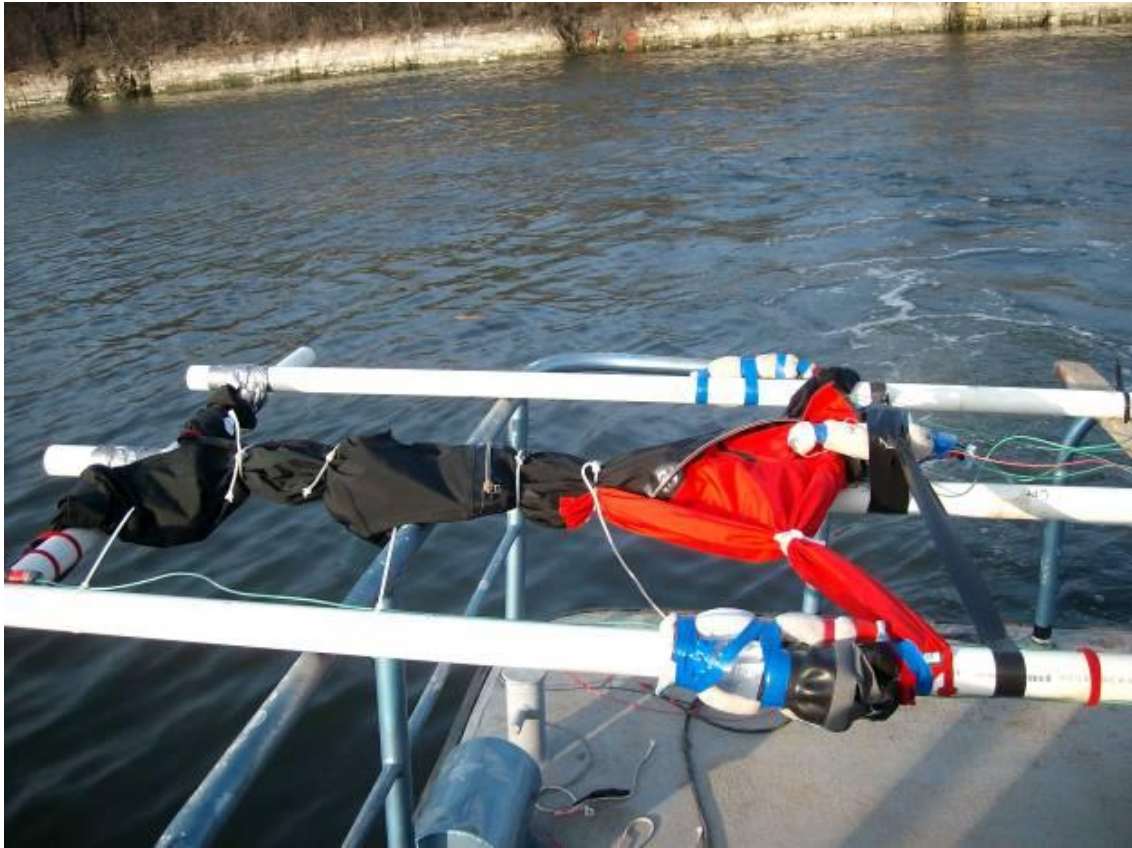
The objective of this test was to measure the electrical current flowing through the chest area of a simulated, dry suit-clad PIW exposed to electric fields while immersed in the CSSC. The test apparatus for this test condition included simulated human input electrodes, but located within and attached to a commercial dry suit with enclosed feet. To measure the dry suit's ability to provide some level of electrical protection to a suited PIW, we placed electrodes to simulate hands in the water, with the exposed neckline/head in the water and the feet enclosed inside the dry suit. The dry suit was completely sealed against water intrusion at the neck and wrists. Figure 14 shows the dry suit apparatus used for this test condition.

Figure 14. Dry suit test apparatus mounted to sensor array frame.

The maximum current noted through the simulated PIW in this condition was 20 mA, which was measured in the vertical direction (wetted head/hand-to-dry foot). This does not represent the maximum possible exposure to a dry-suited person, which in this case would be hand-to-hand. We did not conduct horizontal testing between head/hand-to-foot or hand-to-hand. Because not all possible conditions were evaluated with the dry-suit condition, no specific results were noted for this test condition.

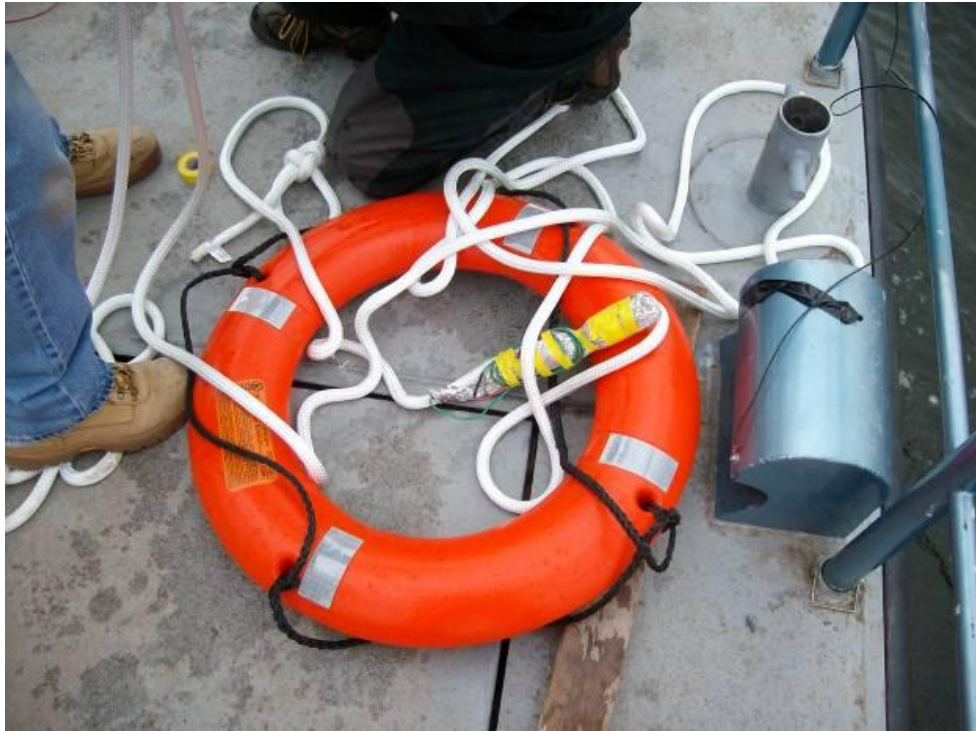
Test Condition 6 evaluated possible electrical circuit paths to a rescuer pulling a PIW to the test vessel or the shore using a soft line or non-conductive rescue hook. This test condition modeled a PIW who was floating in the water, with a pole or line in direct contact with both the PIW and the rescuer. The simulated rescuer was grounded to the test vessel aluminum hull. We modeled the PIW by affixing an input electrode to simulate a low-resistance body in the water to the recovery line/pole, and then to a life-ring to keep the apparatus near the surface. Electrical conductivity simulating the PIW was maximized by wrapping the electrode with aluminum foil. See Figure 15. The test vessel then towed the simulated PIW behind it (see Figure 16) through the electrified zone. We conducted a single transect for each of three test conditions (polypropylene line, nylon line, and non-conductive rescue hook) because side-to-side variability of the measured field was not significant as shown in Test Conditions 1 and 2.

Figure 15. Simulated PIW with input electrode and life ring.

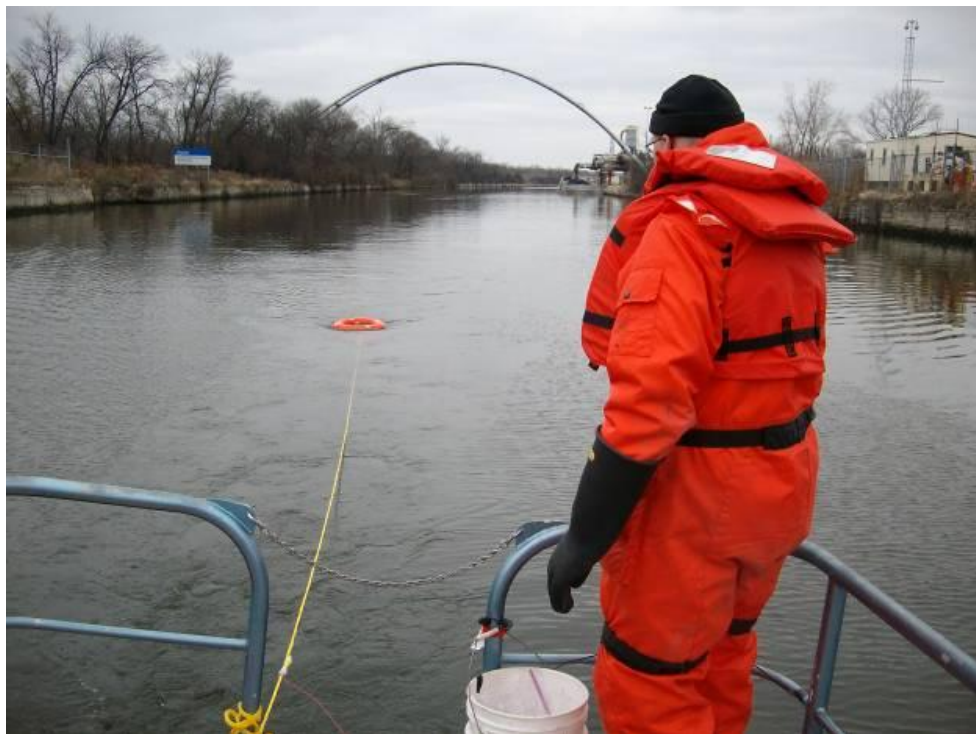
Figure 16. Test vessel towing life ring and simulated PIW with polypropylene recovery line.

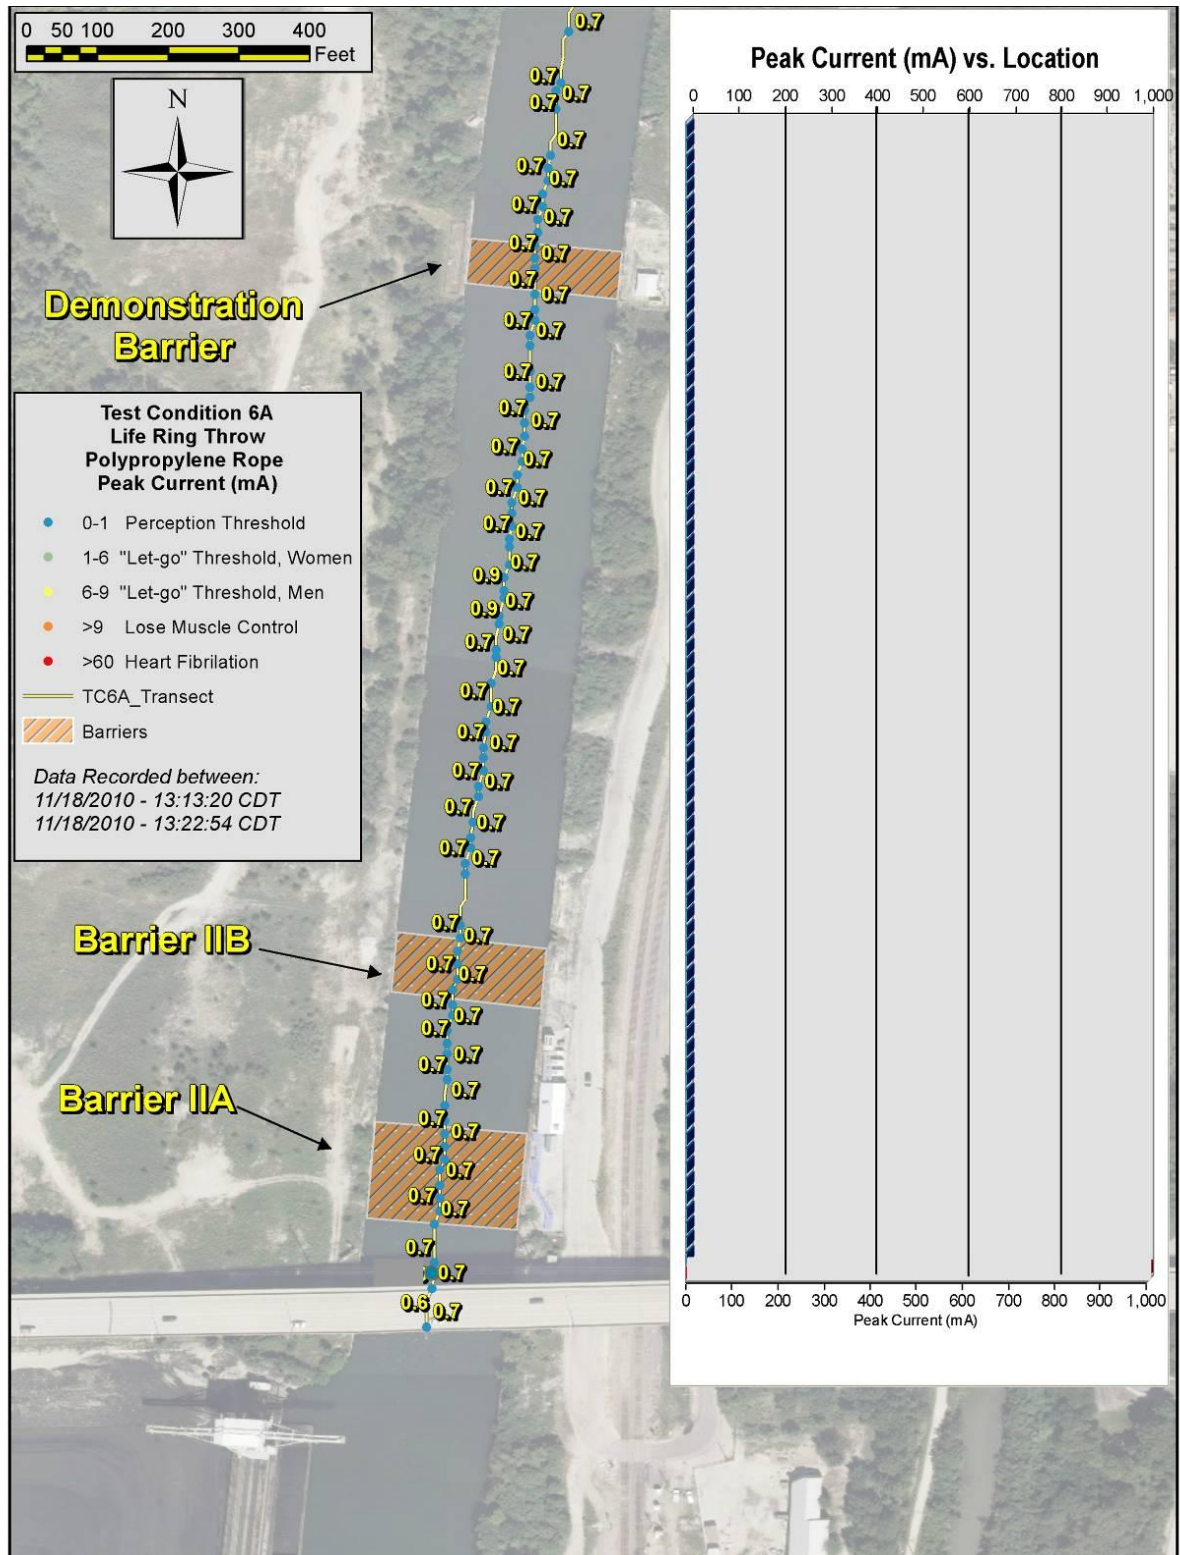
A commercially available life-ring rope bag (Stearns part number #I023ORG-00-000) with a 3/8-inch open-braid polypropylene line served as the test line for this condition. We submerged the rope prior to the test to ensure it was as wet as possible during the electrical current testing. The test vessel towed the simulated PIW and life-ring assembly approximately 30 feet (Figure 16) behind it. A length of the polypropylene line approximately 15 feet in length was out of the water during the tow, simply due to the light weight of the line. We grounded a 100-ohm calibrated resistor to the test vessel hull with a grounding wire and screw to simulate the current path for the rescuer. We tied off a dry section of line to the aft deck rail of the test vessel to provide electrical isolation of the towed apparatus (see Figure 16). Results from this test showed that peak electrical currents to the rescuer were not observable above the RMS background electrical noise of approximately 0.2 mA, or peak noise of less than 1 mA (see Figure 17 and Table 8 (below)).

Figure 17. Peak electrical current through polypropylene line to rescue vessel.

Table 8 summarizes the results of Test Condition 6. Minor electrical currents were seen with a soaked braided nylon line, but produced peak currents of approximately 1.2 mA. Peak current while towing a simulated PIW from the vessel did not produce any measurable data above the background noise levels for either the polypropylene line or non-conductive rescue hook scenario.

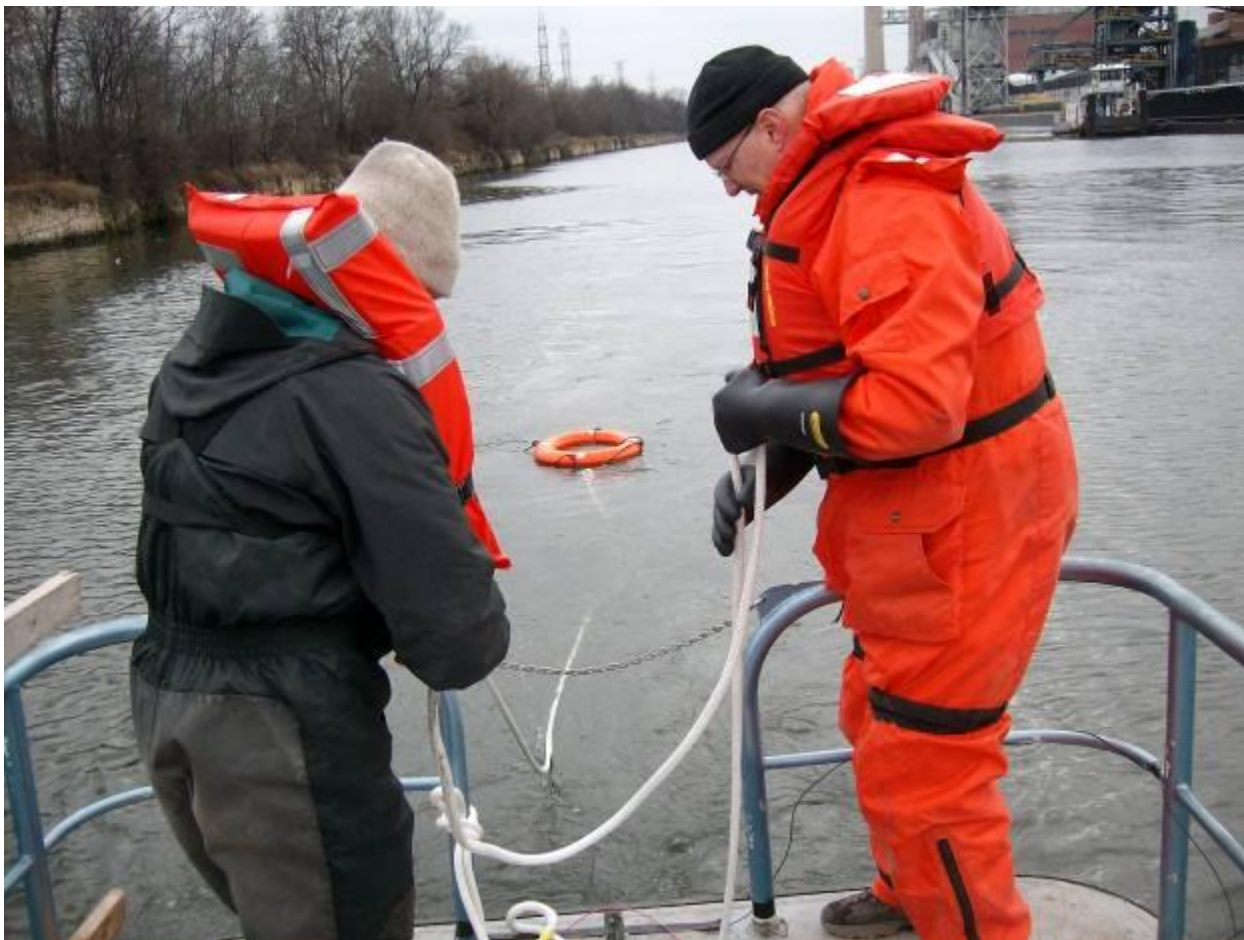
A commercially available nylon-braided dock line (West Marine part number 597239), 5/8-inch diameter, double-braid, served as the test line for this condition (see Figure 18). We submerged the rope prior to the test to ensure it was as wet as possible during the electrical current testing. We assembled the simulated PIW and rescuer as described for the polypropylene line described above.

Unlike the polypropylene line, the nylon-braided line easily retained water and sank when unattended (see Figure 18). We deployed this line while the test vessel was moving to avoid fouling the line in the propeller. Due to the entrained water in this line, results from this test showed that peak electrical currents to the rescuer could be observed at a maximum level of 1.2 mA when transiting over Barrier IIA, which was just slightly above the background RMS noise of 0.3 mA (see Figure 19 and Table 8 (below)).

Figure 18. Life ring deployment with nylon double braid recovery line.

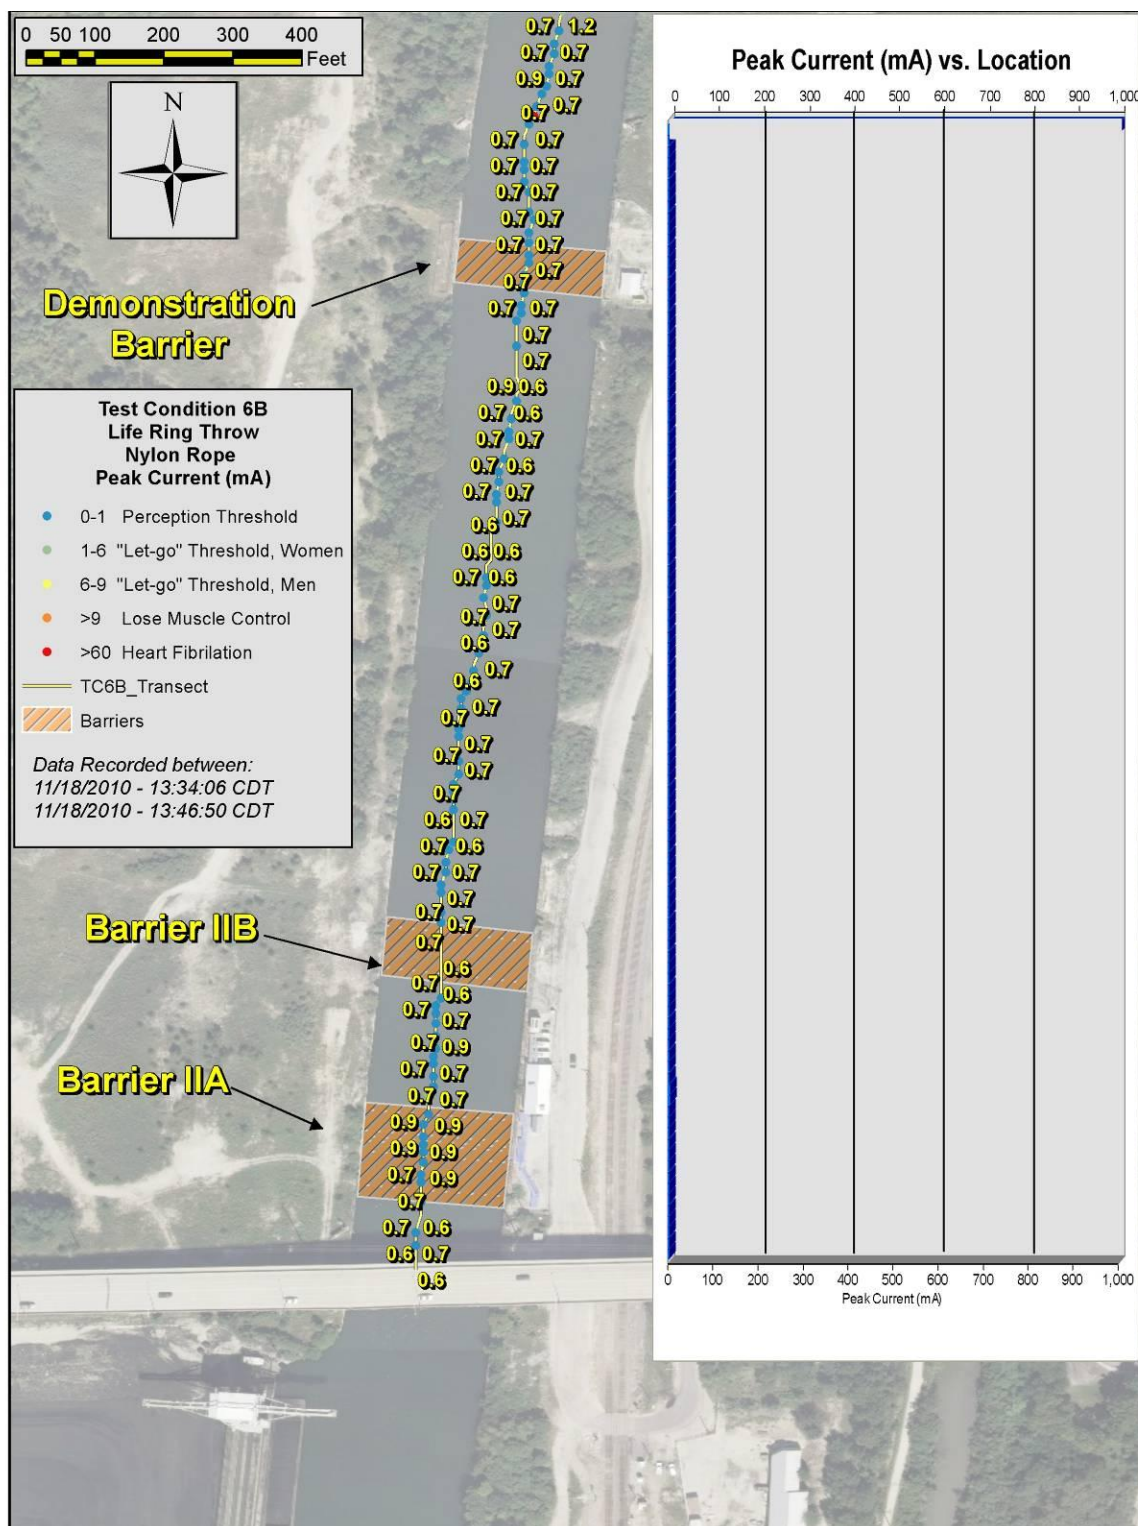
Figure 19. Peak electrical current through braided nylon line to rescue vessel.
